AGUA HEDIONDA 2019 ANNUAL REPORT

Prepared by Karen Merrill and Ellen Bartlett, Preserve Calavera, North San Diego County Watershed Monitoring Program

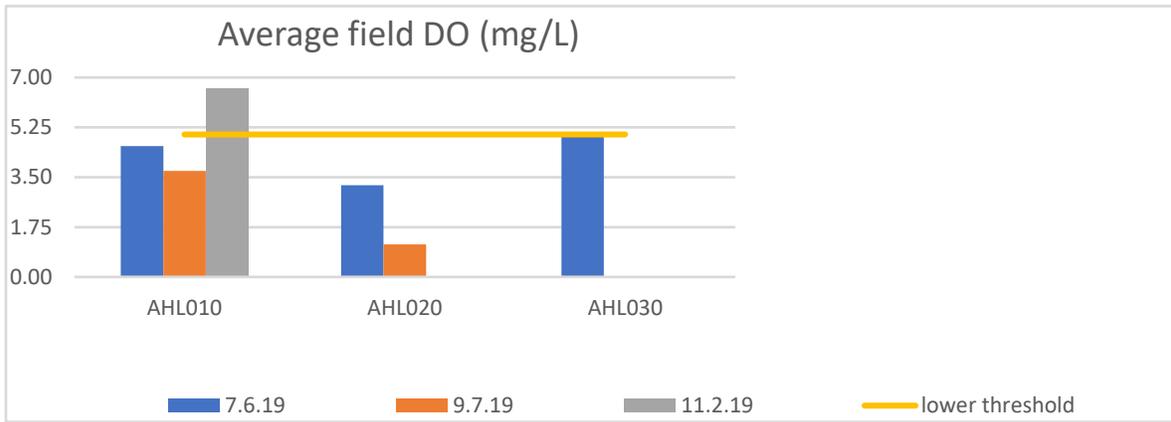
Dissolved Oxygen: Dissolved oxygen was at or below the San Diego Basin Plan⁴ threshold of 5.0 mg/L, with the exception of AHL010 on 11/02. These levels generally do not represent a sufficient amount of oxygen in the water for a healthy ecosystem. Aquatic animals have a varied tolerance for low dissolved oxygen and anything below 5.0 mg/L can impact the creek’s biodiversity.

Below threshold levels of dissolved oxygen are cause for concern.

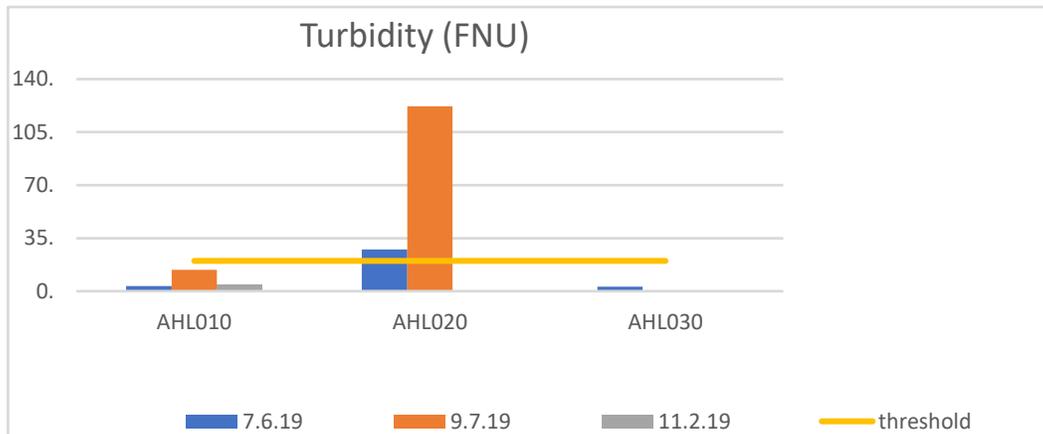
Turbidity: High turbidity can hinder the quantity light penetrating water which may affect photosynthesis. The threshold is 20 FNU. AHL010 was well within threshold level throughout 2019. AHL020 showed above threshold readings on both measured dates. On 9/07, the turbidity reading was more than 5X the threshold level. It was noted on the data sheet (see Appendix B) that the water was clearly rust colored and the collection site depth was only 3.5 inches making collection difficult without disturbing the bottom sediment.

The turbidity of the water at site AHL020, appearing to be rust colored, should be monitored. The value and results of taking samples when the collection site depth is very low should also be evaluated.

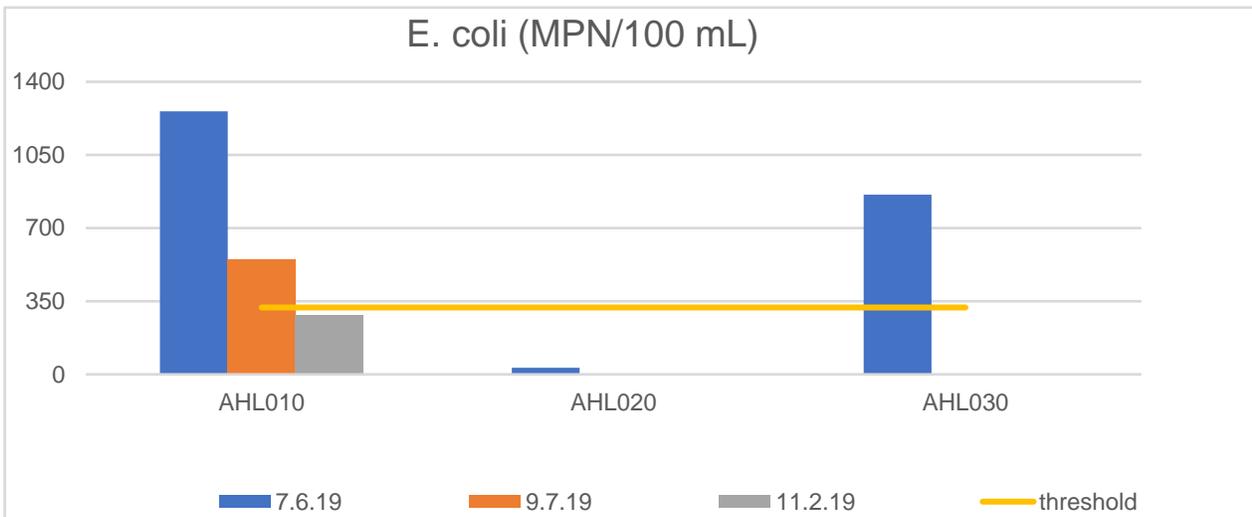
E. coli: Coliforms are a group of bacteria found in the digestive tracts of animals, including humans and their waste products. They are also found in plant and soil material. They may or may not indicate pathogenic bacteria. There is no threshold for these bacteria due to the wide types of sources. *E. coli*, however, is much more indicative of potential concern as many strains are pathogenic. The test we run, using [IDEXX Quanti-tray/Colilert](#), measures all *E. coli*, pathogenic or not. The threshold for this bacteria is 320 MPN/100 mL³. *E. coli* levels at AHL010 were well above threshold levels at all two of the three testing dates as was the single testing date for AHL030. AHL020's single testing date showed *E. coli* levels were well below the threshold.

E.coli levels continue to be above the threshold in sites AHL010 and AHL030 which is cause for concern. This may be due to the fact that AHL010 is a convergence of all of the creeks and we only test two of the creeks. We don't test Little Encinas or other tributaries.

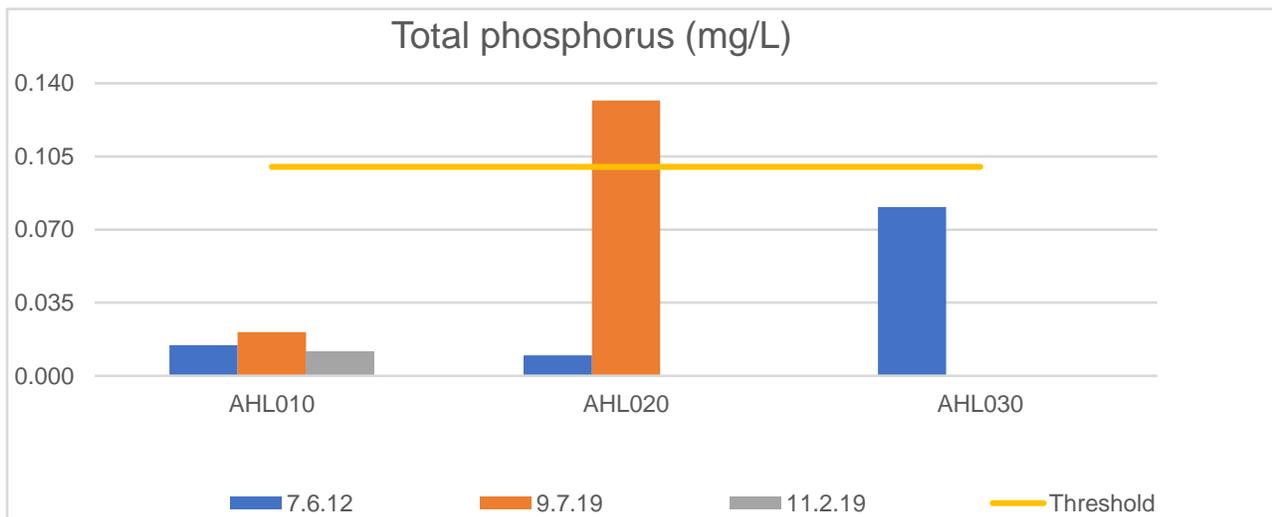
Total Phosphorus: Elevated phosphorus is often the result of fertilizer runoff and can lead to algal blooms. The threshold for San Diego watersheds is 0.1 mg/L³. At AHL010 total phosphorus was well below the threshold. The upstream sites had limited data available due to dry beds during parts of the year but phosphorus levels were above the threshold at AHL020 on 9/07.

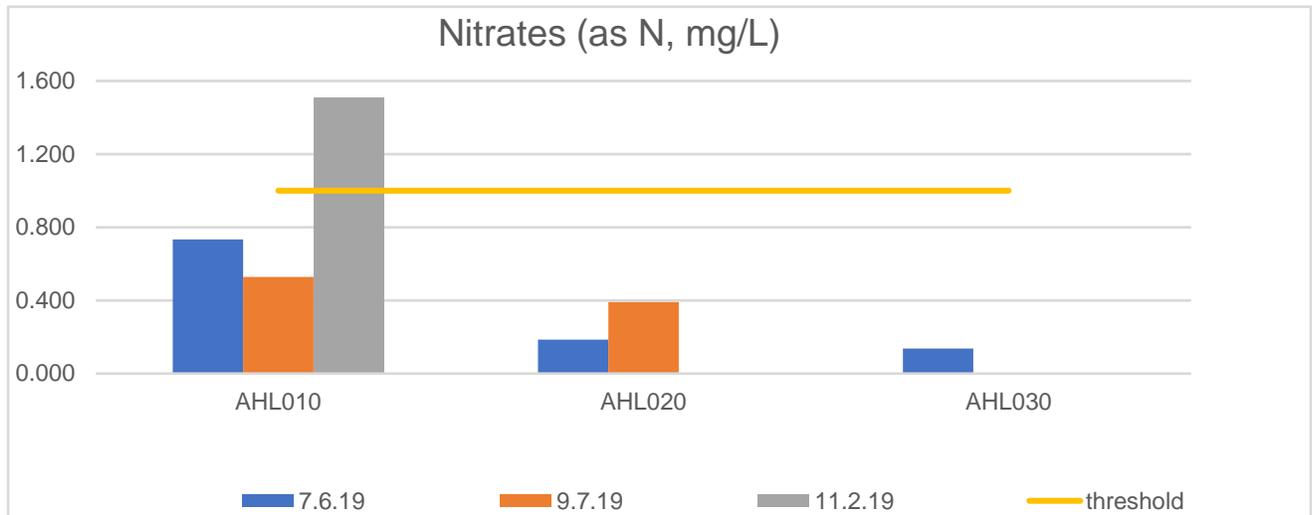
Nitrates: Nitrates generally enter waterways from fertilizer runoff. Site levels were below threshold of 1.0 mg/L with the exception of the downstream site AHL010 which was above the threshold on 11/02. AHL010 overall had higher nitrate levels than the upstream sites.

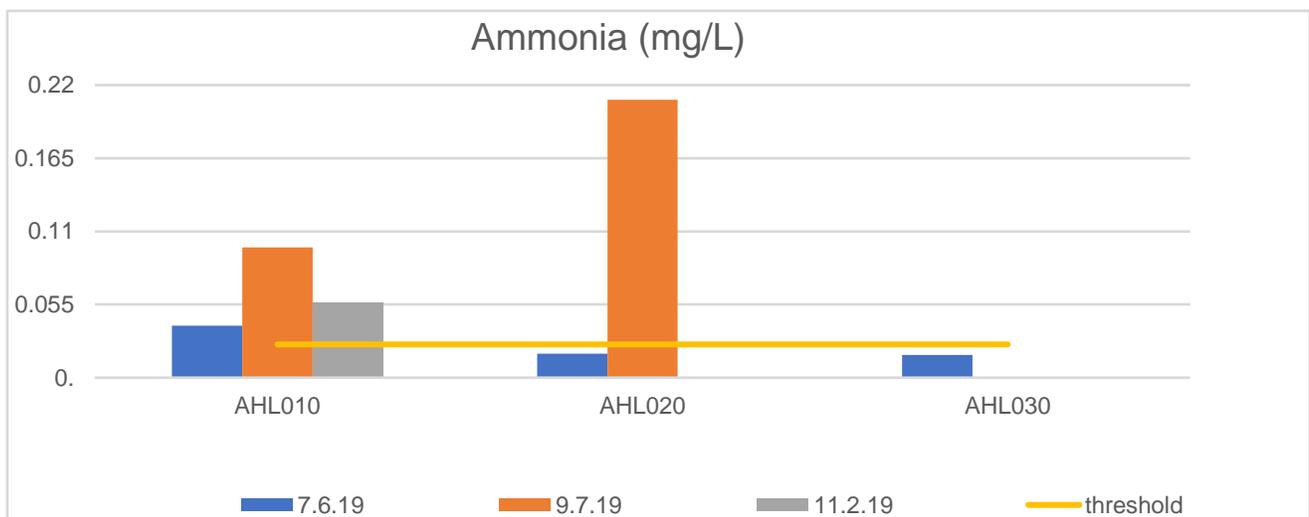
Ammonia-Ammonia is another form of nitrogen. It can cause direct toxic effects on aquatic life. Ammonia can enter waterways through direct means such as municipal effluent discharges and the excretion of nitrogenous wastes from animals, and indirect means such as runoff from agricultural lands. Ammonia's threshold is 0.025 mg/L. In the July testing, ammonia was below threshold for upstream sites but above the threshold for AHL010. Ammonia was over threshold, which is 0.025 at both sites tested in September and November. AHL020 measurement in September was an outlier and could be due to an error.

It should be noted that field samples gathered for ammonia testing did not have their pH lowered to below 2 as recommended by the manufacturer (Hach) as we followed SDCK procedures which also did not follow recommended protocol.
