BUENA VISTA CREEK 2021 ANNUAL REPORT

Prepared by Paige DeCino, Preserve Calavera, North San Diego County Watershed Monitoring Program, Local Project Director

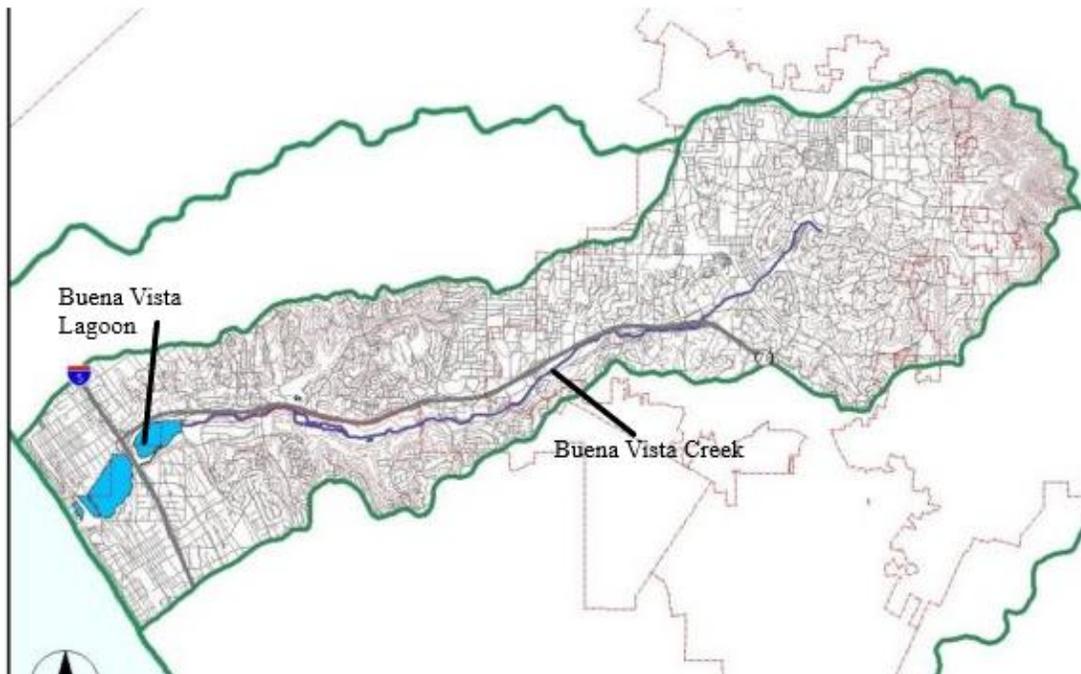
Figure 1 – Buena Vista Creek Watershed¹

Buena Vista Lagoon which is part of both Oceanside and Carlsbad is fed by Buena Vista Creek whose headwaters are on the western slopes of the San Marcos Mountains, Buena Vista Creek is the only creek feeding Buena Vista Lagoon which opens to the Pacific Ocean. Currently, due to a weir put in place in the 1940s near the mouth of the lagoon, it is freshwater and in a steady

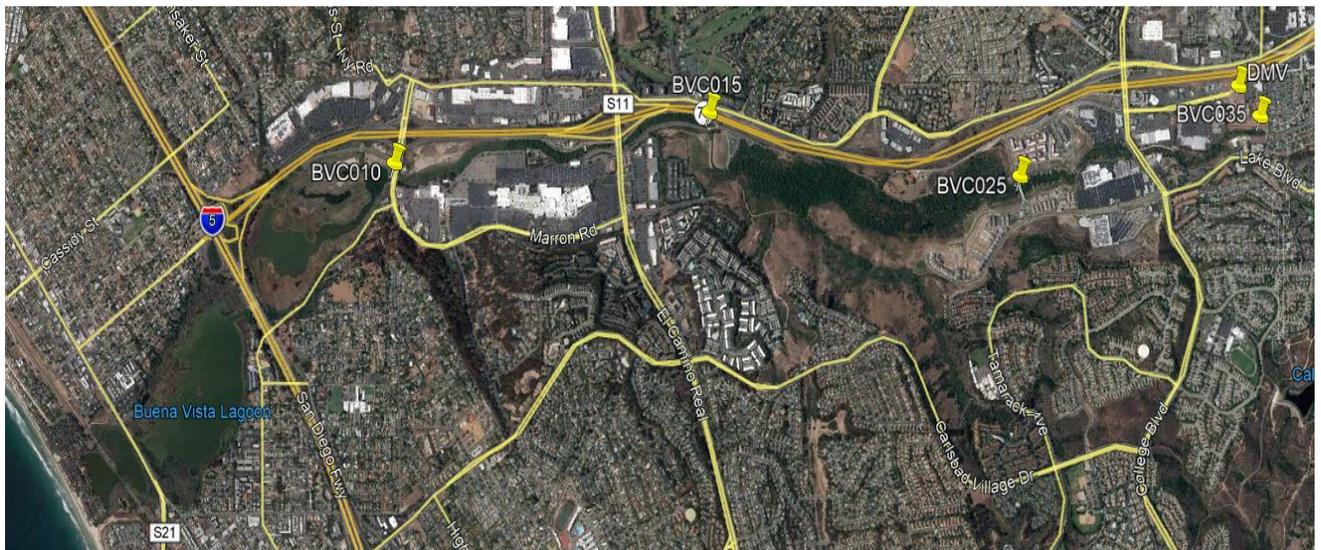
Figure 2 - Buena Vista Creek sampling sites

The Buena Vista Creek team sampled the 4 sites along the creek (BVC010, BVC015, BVC025 and BVC035). The site identifications in the map below are the same as those used by SDCK at various times between 2009-2018. Site BVC025 within the Preserve housing development (formerly Quarry Creek) was added to our sampling regimen midyear only for bacteria as we were concerned about periodic spikes in *E. coli* downstream at site BVC015.

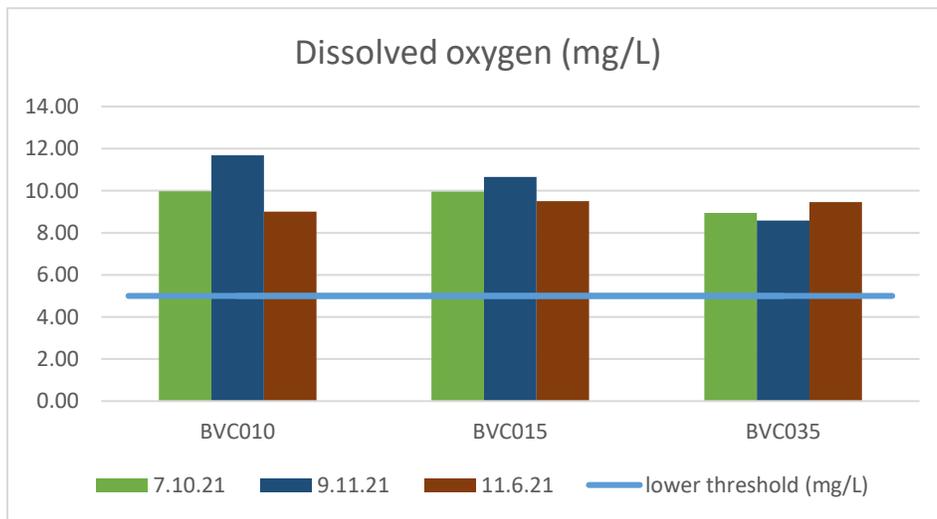
Dissolved oxygen (DO) was consistently above the San Diego Basin Plan[®] threshold of 5.0 mg/L, generally ranging above 6.0 and below 14.0 mg/L at all 3 sites. These levels represent a healthy amount of oxygen in the water for aquatic animals. Because of COVID restrictions rolled over from 2020, dissolved oxygen was not measured until July 2021, hence, the data is only available for the latter half of 2021.

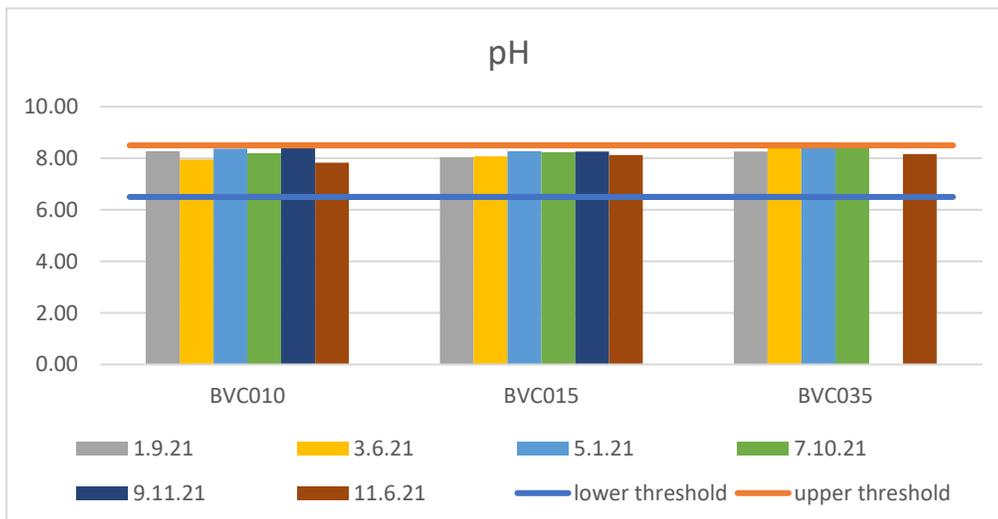
From January through May, the pH was measured in the lab. It continued to be within acceptable limits. Thereafter, with loosened COVID restrictions, we returned to measuring pH in the field. The September measurement for BVC035 was incorrectly recorded and, therefore, not included.

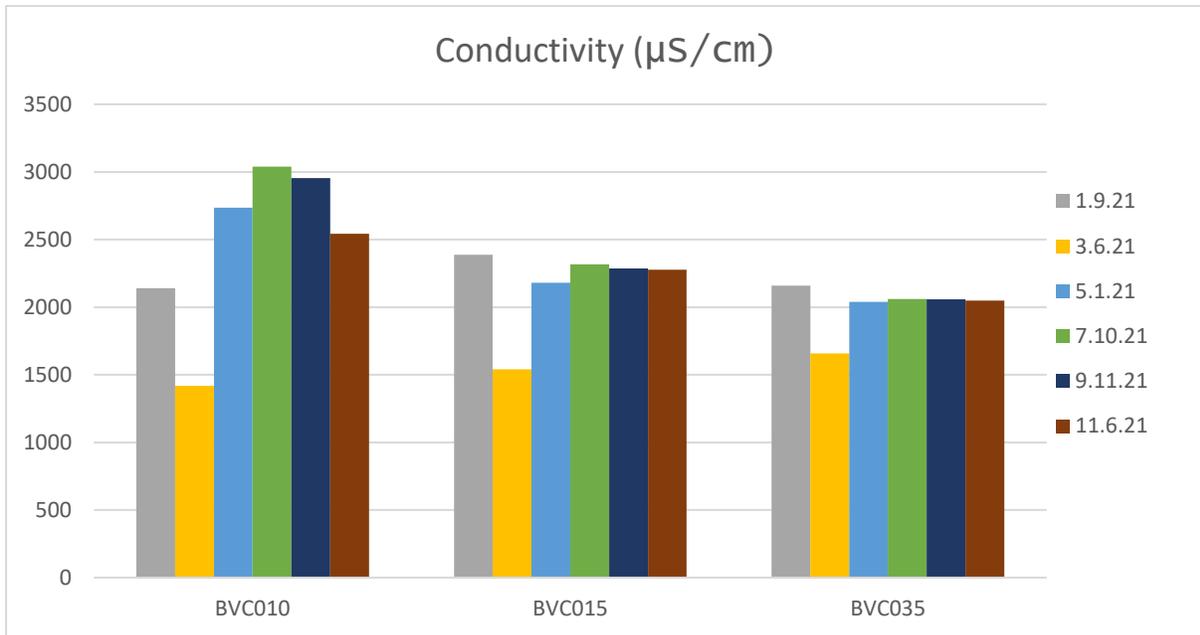
Conductivity fluctuated between about 1500 and 3000 $\mu\text{S}/\text{cm}$. This compares with historic data for this parameter. There is no threshold for conductivity, it merely reflects the amount of dissolved minerals in the water.

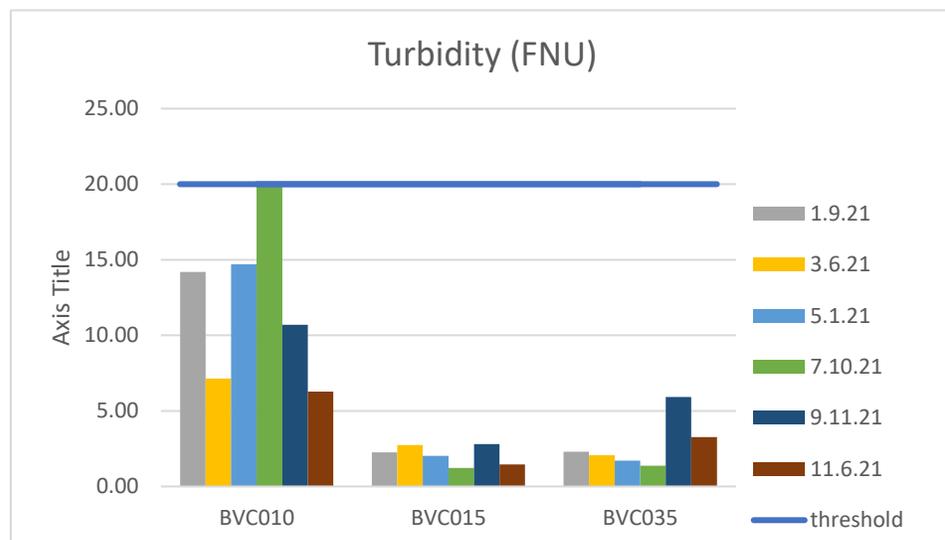
High turbidity can hinder light penetrating water which may affect photosynthesis. The threshold is 20 FNU. For our sites, the turbidity was within an acceptable range although site BVC010 was consistently higher than the upstream sites..

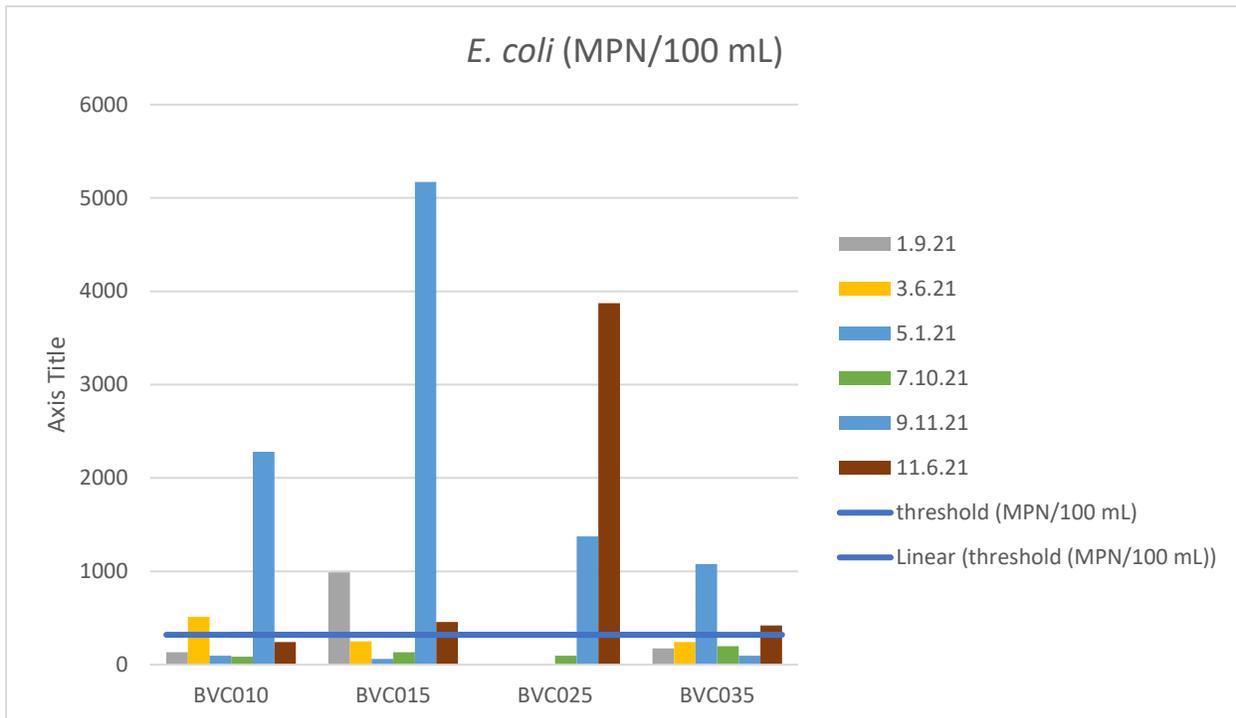
The September event, with light rain in some parts of the watershed, shows high E. coli measurements at 3 of our 4 sites. All sites exhibited an occasional spike above threshold for E. coli even though the other sites remained acceptable. These data were shared with the Carlsbad Stormwater manager and to the best of our knowledge no source was identified although sites BVC035 and BCV025 are within or just downstream of well documented homeless encampments.

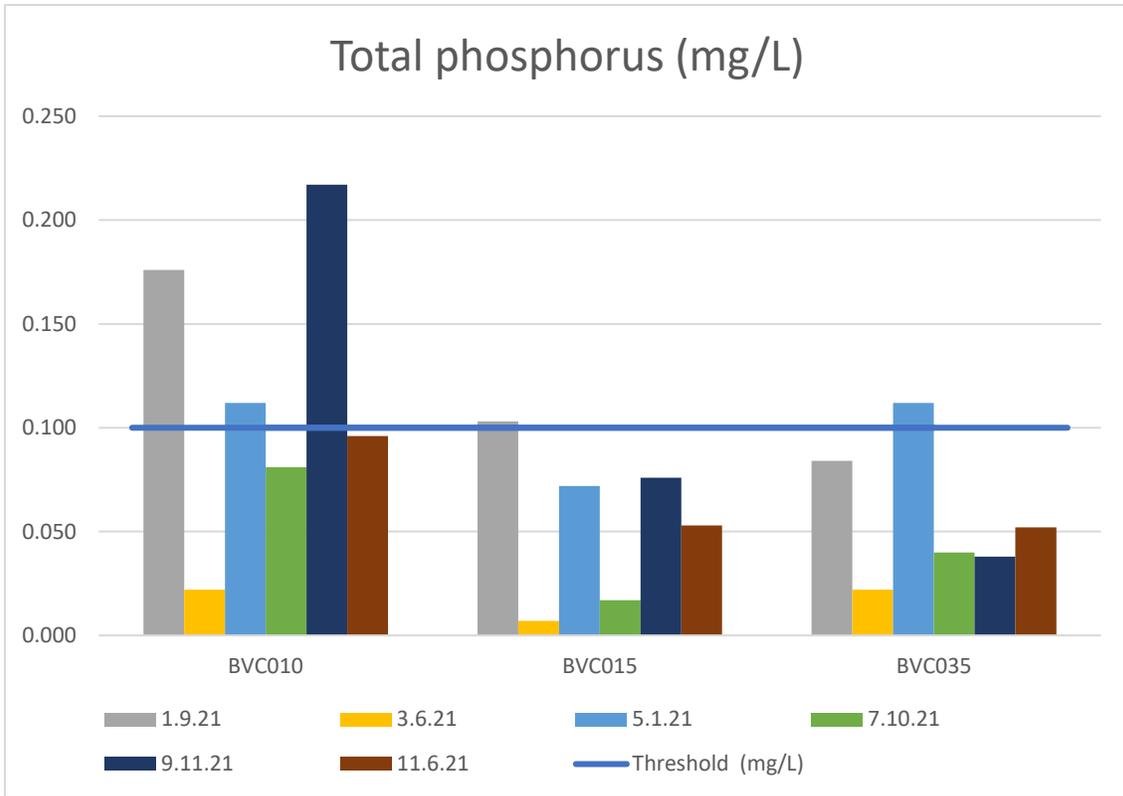
Elevated phosphorus is often the result of fertilizer runoff and can lead to algal blooms. The threshold for San Diego watersheds is 0.1 mg/L³. BVC010 at the east end of the lagoon was frequently over threshold. The other sites were generally acceptable.

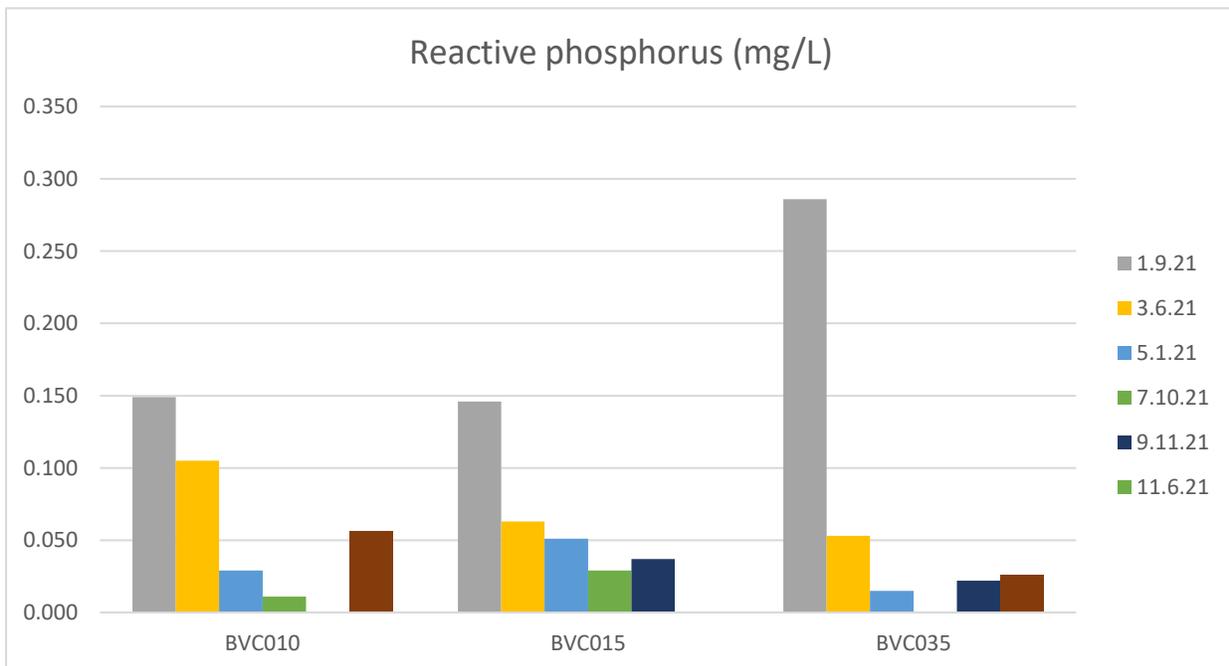
Reactive phosphorus should be less than the total phosphorus but as you can see between these two graphs, that is not always the case. (e.g., BVC025). Our technical advisor suggests that the 'matrix' (the components in the water sample) may be affecting the results, especially when conductivity is greater than 2000 $\mu\text{S}/\text{cm}$. During 2021, we will be addressing this anomaly. For further reading see this [link](#).

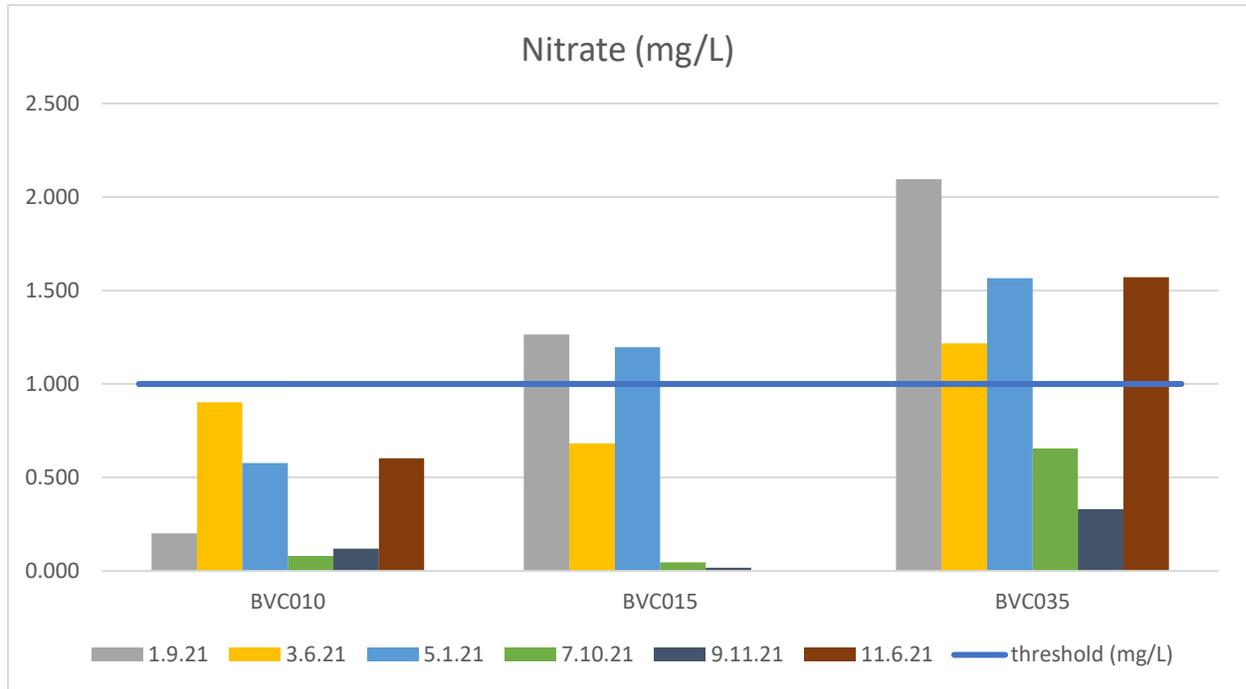
Nitrates, too, generally come from fertilizer runoff. BVC035 was the most likely site to be over threshold with BVC015 being high over the first six months of 2021 and then dropping very low. BVC010, at the head of the lagoon, was consistently below threshold.

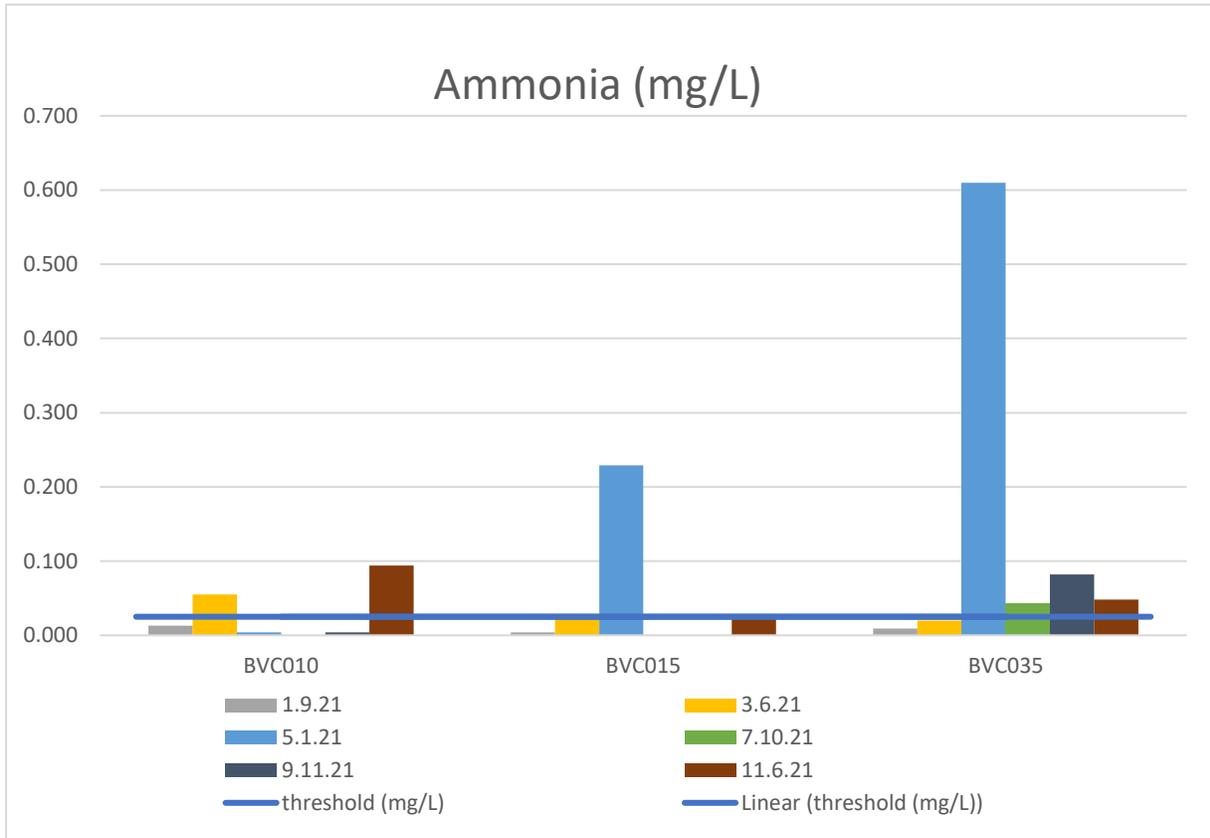
Lastly, ammonia⁴, whose threshold was 0.025 mg/L was often above (significantly) this level. Natural sources of ammonia come from the breakdown of organic wastes, forest fires, animal from runoff and human waste, exchange with the atmosphere and nitrogen fixation. While variable over time and space, the levels of ammonia are of concern with levels sometimes 20 times above threshold. The site, BVC035, furthest upstream was mostly likely to be high. We cannot identify the source of this pollution.

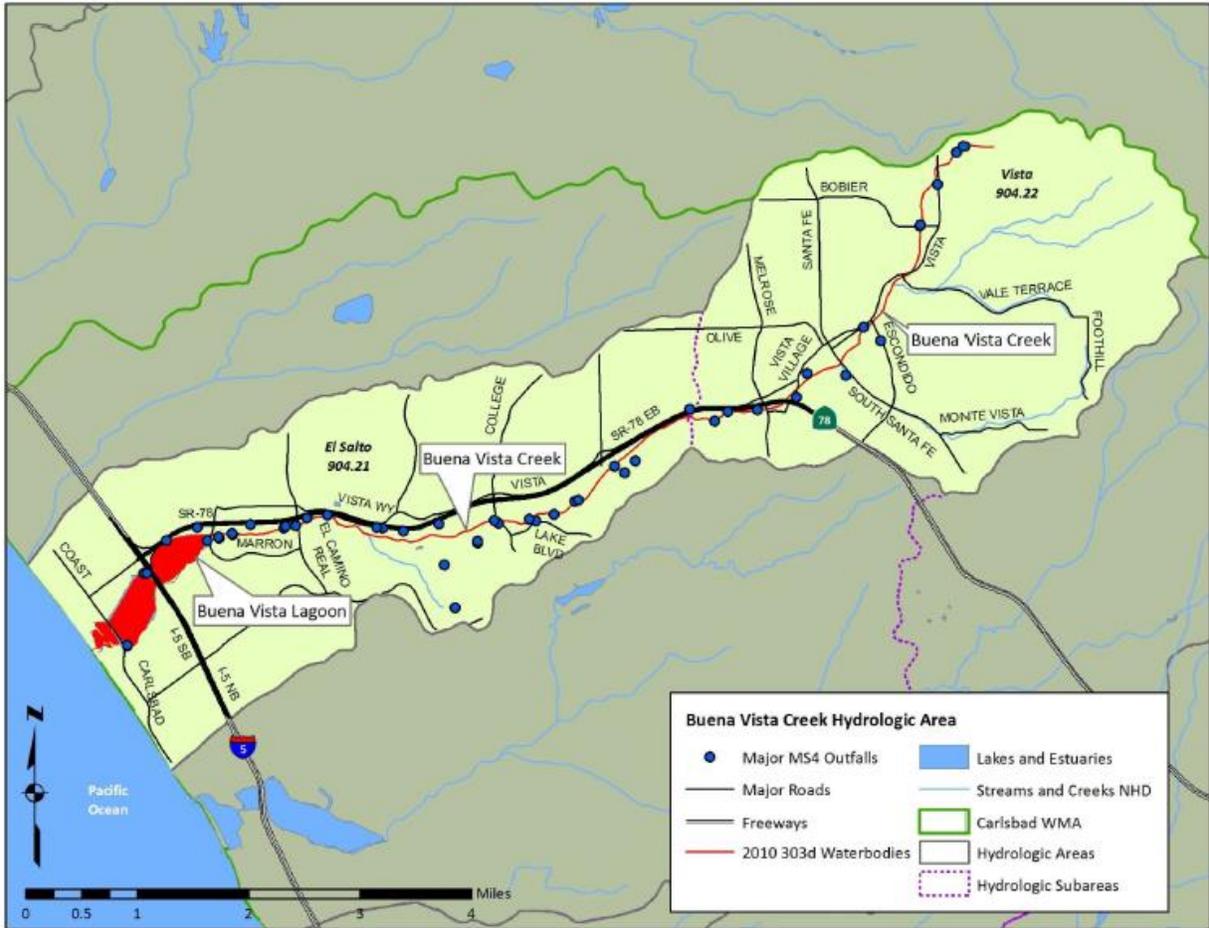
Figure A-2: Buena Vista Creek HA – Major Outfall Information

As you can see from the MS4 outfall map, the creek and lagoon are on the 303(d) list which indicates impairment from one or more pollutants (e.g., bacteria, sediment, nutrients).

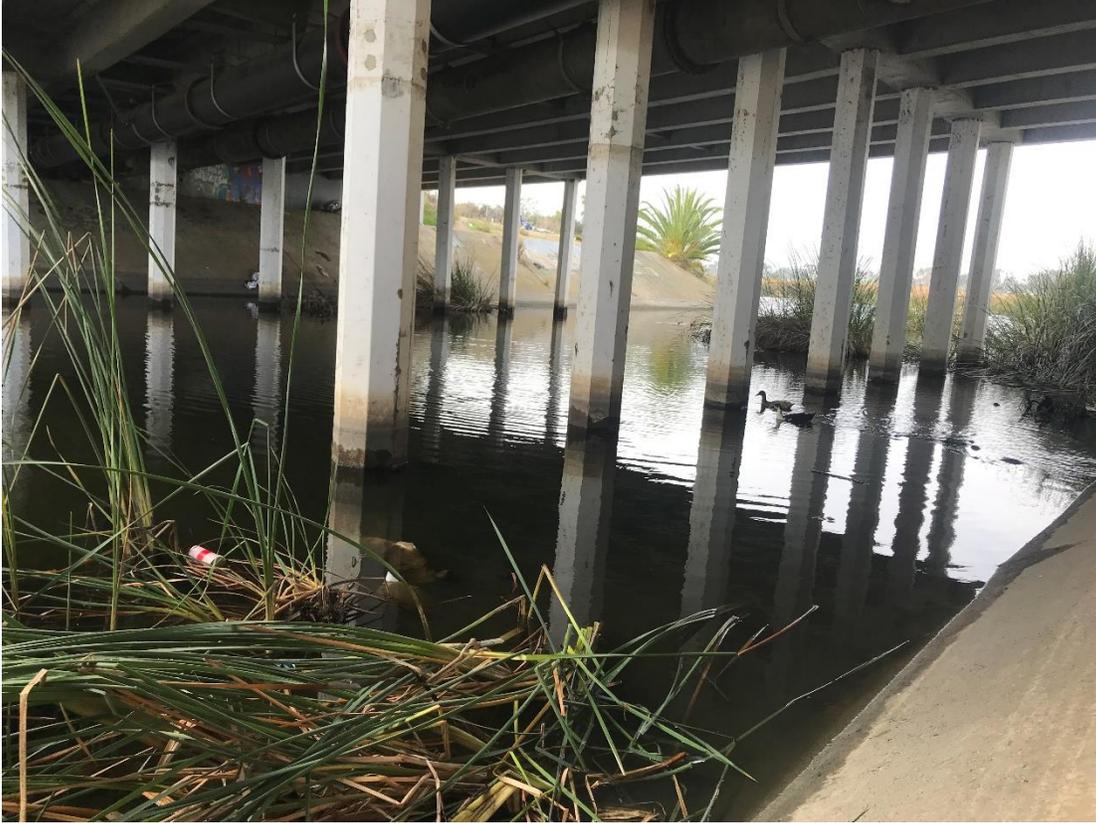
BVC010

Under Jefferson St bridge looking west.

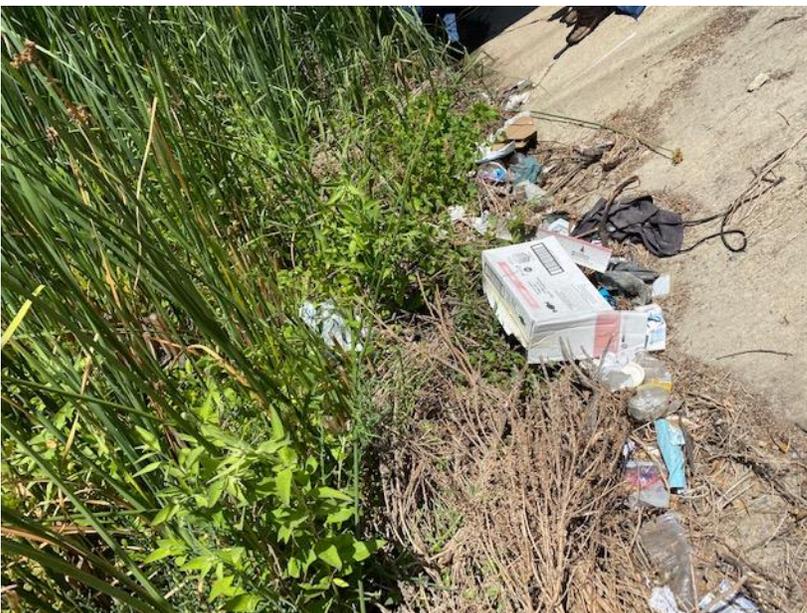
Typical trash at BVC010 site:

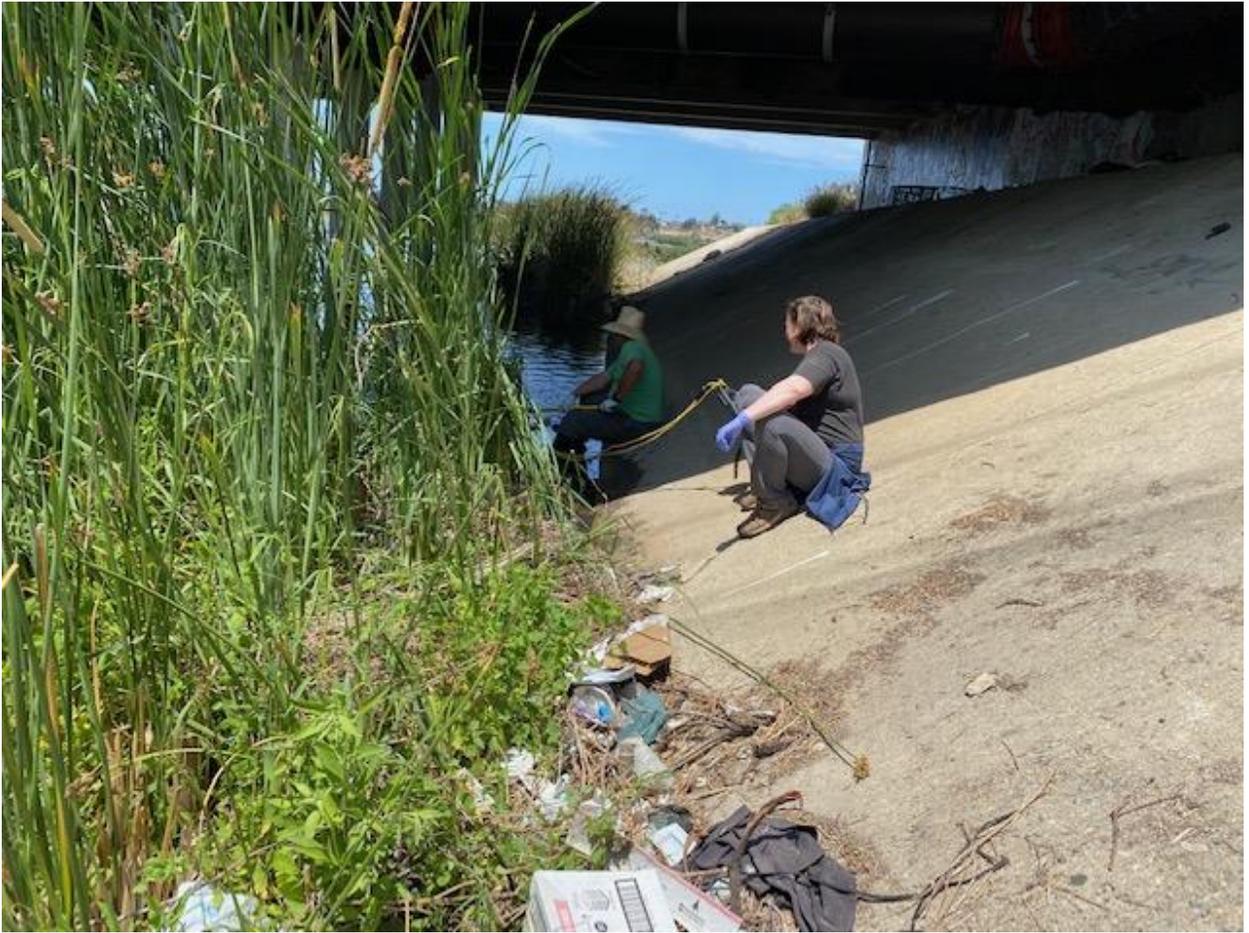
Rather tenuous collection site topography:

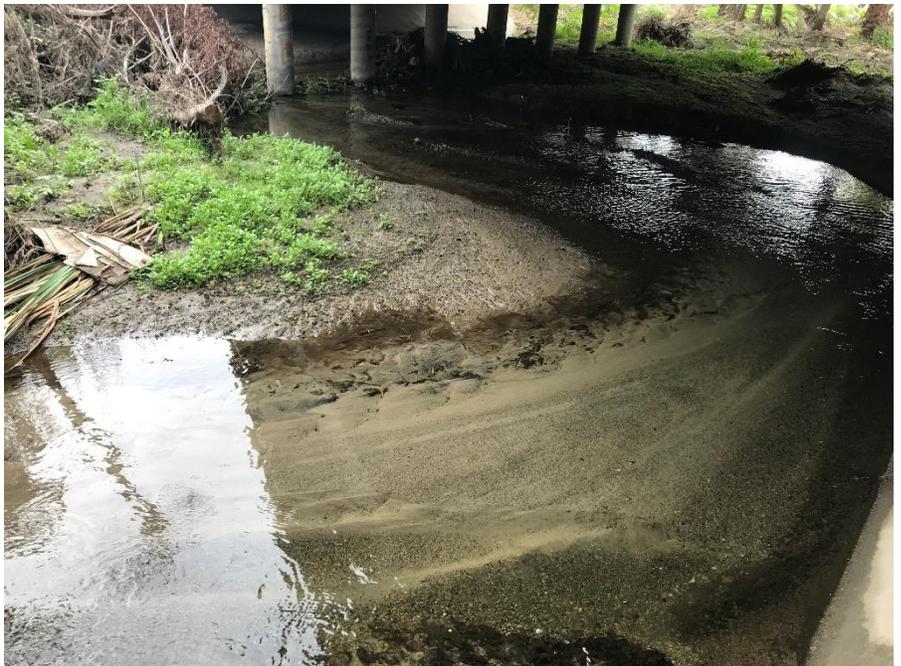
BVC015 – near Haymar driving range. Very typical photo.

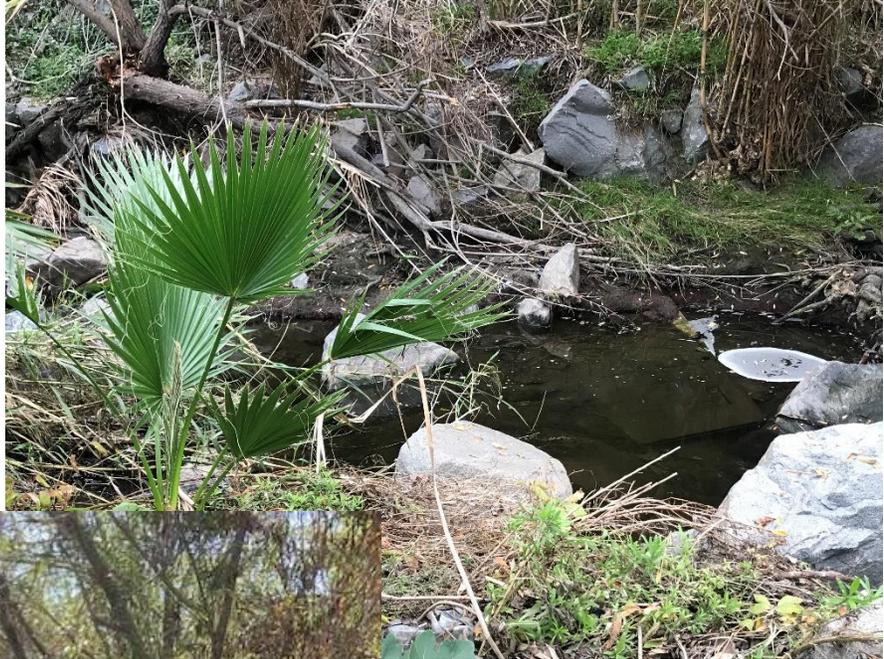
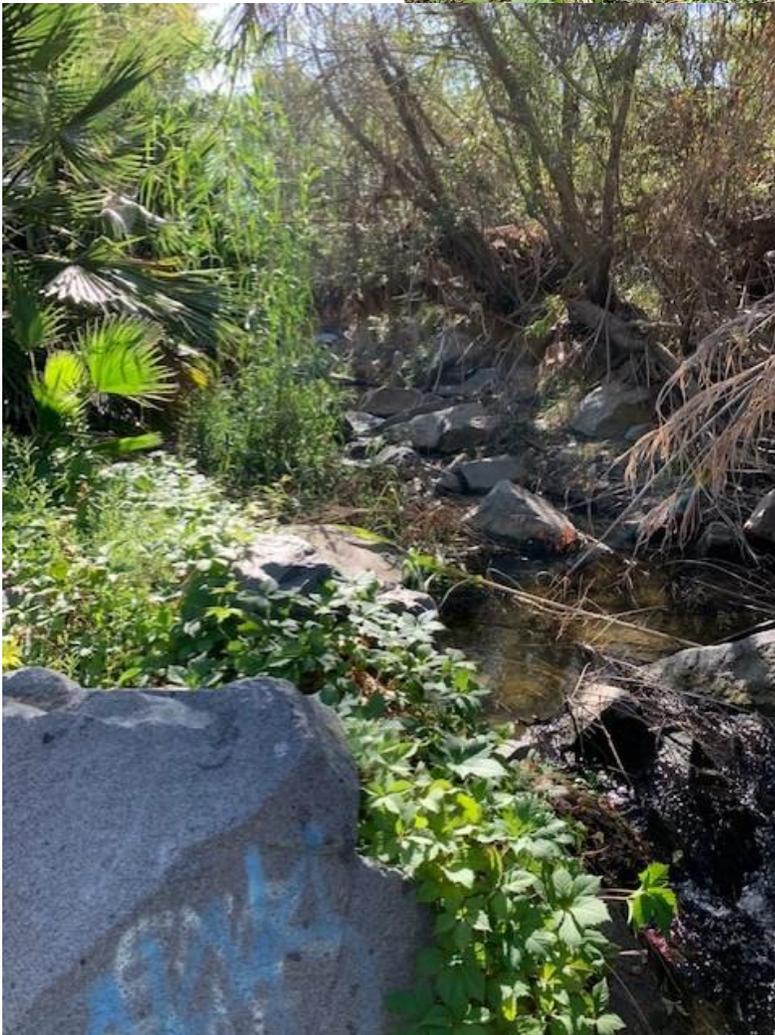
BVC035 – On Thunder Dr, near Oceanside DMV

BVC035 near the Oceanside DMV, was within acceptable range for all field tests. For nutrients, while often above the acceptable levels, were better than 2020. *E. coli* spiked in May as did all the other sites.
