AGUA HEDIONDA 2022 ANNUAL REPORT

Prepared by Karen Merrill and Ellen Bartlett, Preserve Calavera, North San Diego County Watershed Monitoring Program

Purpose

The purpose of this annual report is to provide the water testing data for Agua Hedionda Creek Watershed that was collected during 2022 (Appendix). Each parameter will be evaluated for anomalies and the overall trends of the watershed will be summarized based upon this data. Monitoring was carried out in January, March, July, September and November of 2022. The data will also be compared with our previous years of data from 2021, 2020 and 2019, as well as 2018 and 2017 data that was collected by San Diego Coastkeeper. Environmental DNA (eDNA) was also collected at one testing site as part of a pilot program.

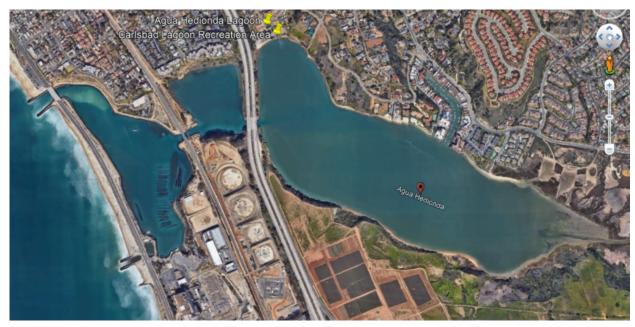
Figure 3: Agua Hedionda Lagoon; It's three sections are visible (Source: Google Maps)

Agua Hedionda is the only lagoon in San Diego County which supports commercial and recreational uses. Carlsbad Desalinization Plant, Hubbs Seaworld fish hatchery and Carlsbad Aquafarm are at the west end; Ecke Family YMCA Aquatic Park, California Watersports and boat ramps are in the center section and a state ecological reserve and nature center are at the east end. The inner lagoon is designated REC-1 beneficial use (water sports) and the outer lagoon SHELL-1 for the aquafarm.

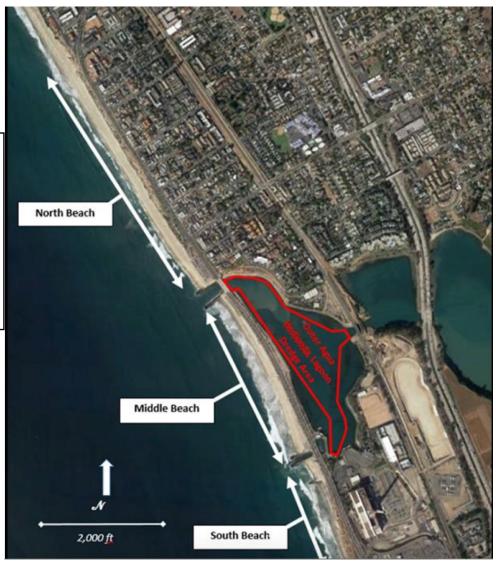
Figure 5: Project Location
Map for Dredging and
Sand Replacement. Red
outline indicates dredging
area. (Source: Agua
Hedionda Lagoon - Outer
Basin 2020-21
Maintenance Dredge/
Beach Nourishment Cycle
Sand Deposition Plan)

As a result of accumulated sedimentation, and the absence of significant tidal flushing, the lagoon was becoming an increasingly restricted salt water marsh. The entire lagoon was dredged and permanently opened to the sea between 1952 to 1954 to provide a tidal prism adequate enough to supply cooling water for the San Diego Gas and Electric Company's Encina Power Plant located on the south side of the outer lagoon. The resultant deepening and tidal flushing created a new deepwater bay environment.

The lagoon has been dredged every one to four years since 1954. This began as part of the Encina power plant operations. Now that the Encina plant has been retired, Poseidon Water has taken over the dredging, as part of an agreement when the seawater desalination plant was built and came online in 2015.¹ Regular dredging is needed to remove sand that slowly enters the lagoon and forms a large sand bar in the western-most part of the lagoon. Dredging was most recently conducted from February of 2021 through mid-April of 2021.

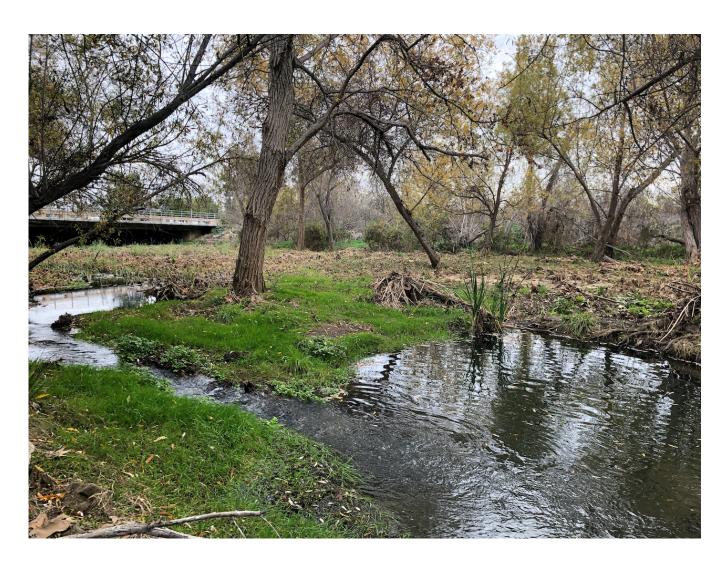
Site AHL010

- <u>AHL010</u>-Samples the convergence of Calavera Creek, Agua Hedionda Creek, and other tributaries.
 This site is located at the eastern end of lagoon before recreational areas; close to the intersection of Cannon Rd and El Camino Real. There is no public access in the sample area.
- <u>AHL020-Samples</u> Calavera Creek in the Lake Calavera Preserve in Carlsbad. This site is protected open space.
- <u>AHL030</u>-Samples Agua Hedionda Creek under south Melrose in Vista. This site is at the very eastern
 most edge of Buena Vista Park. There is residential development to the east and undeveloped lands
 to the west.
