AGUA HEDIONDA 2019 ANNUAL REPORT

Prepared by Karen Merrill and Ellen Bartlett, Preserve Calavera, North San Diego County Watershed Monitoring Program

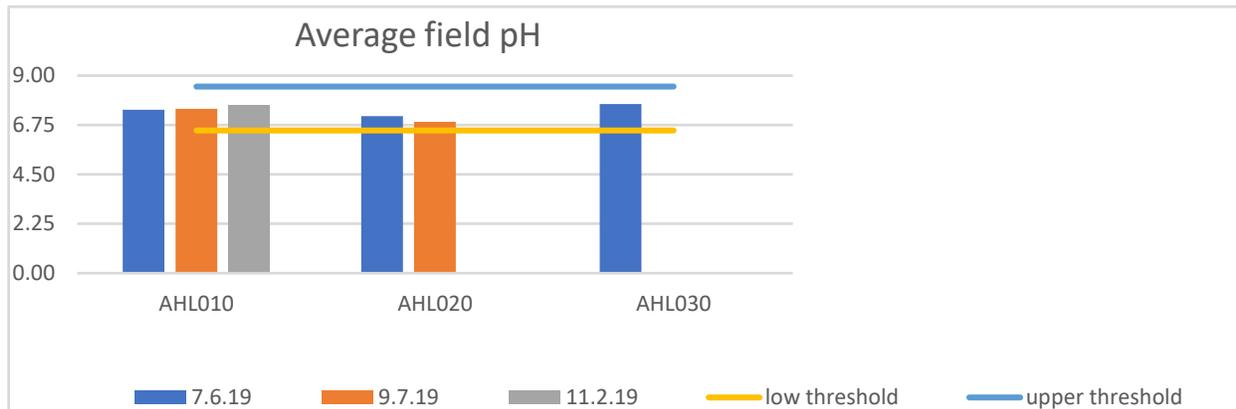
pH: The pH ranged from 6.9 to 7.7 for all sites. This falls within the acceptable range for the Basin Plan³ of 6.5-8.5

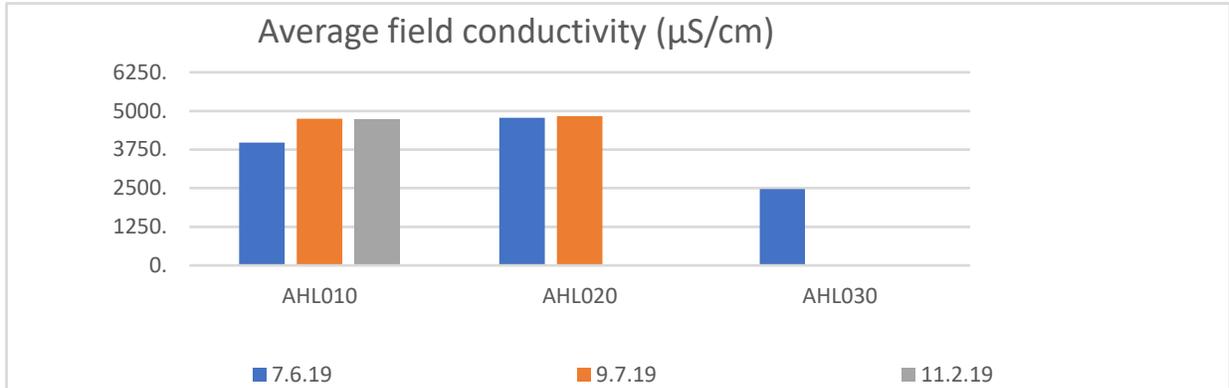
Conductivity: Conductivity fluctuated between 2500-4800 $\mu\text{S}/\text{cm}$. There is no threshold for conductivity, it merely reflects the amount of dissolved minerals in the water, however, the California Waterboard typically sees levels between 100-2000 $\mu\text{S}/\text{cm}$ in freshwater streams ([Electrical Conductivity/Salinity Fact Sheet](#)).

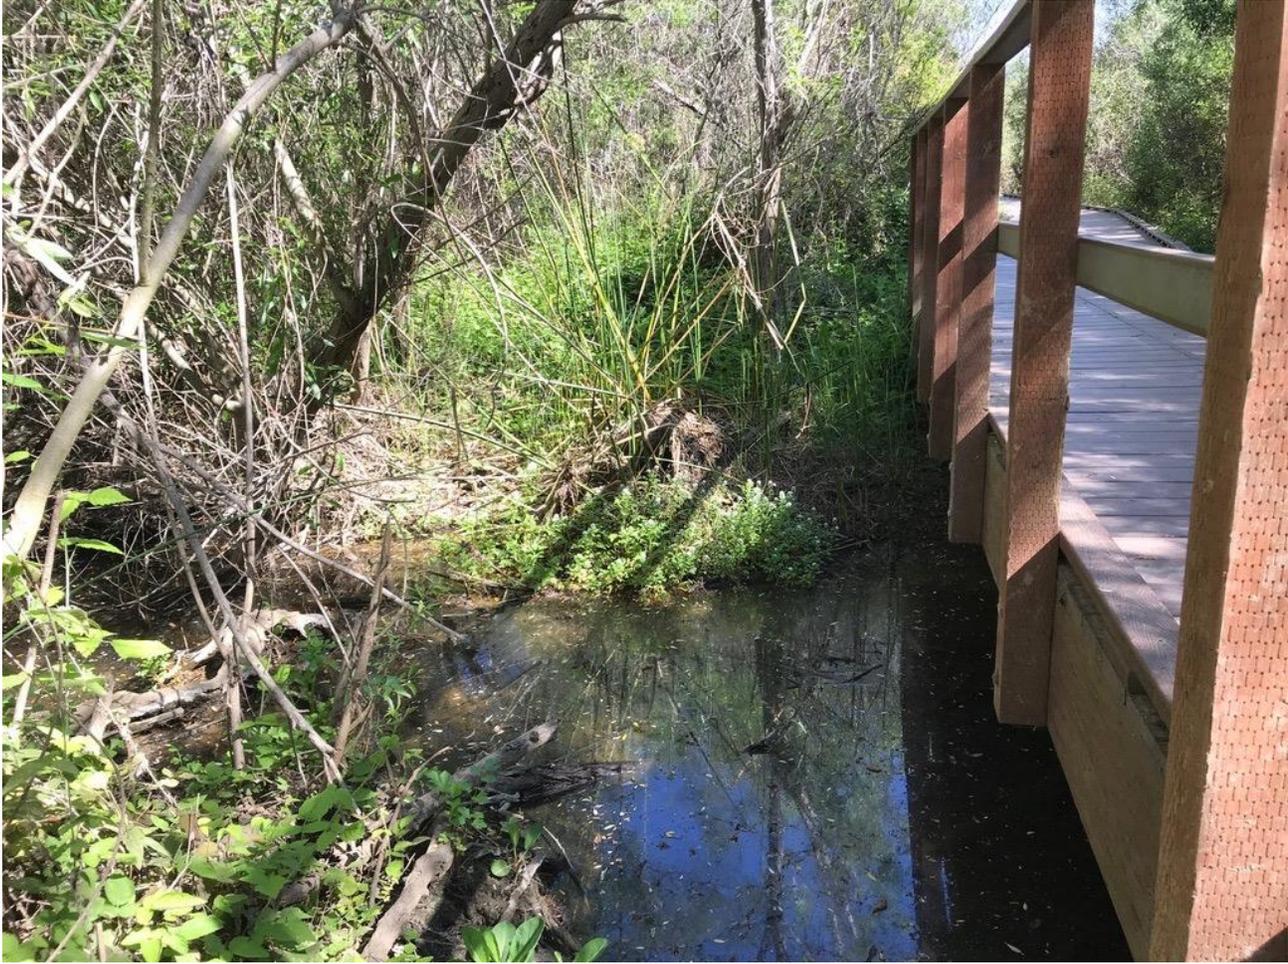
Site AHL020

The turbidity of the water at site AHL020, appearing to be rust colored, should be monitored. The value and results of taking samples when the collection site depth is very low should also be evaluated.

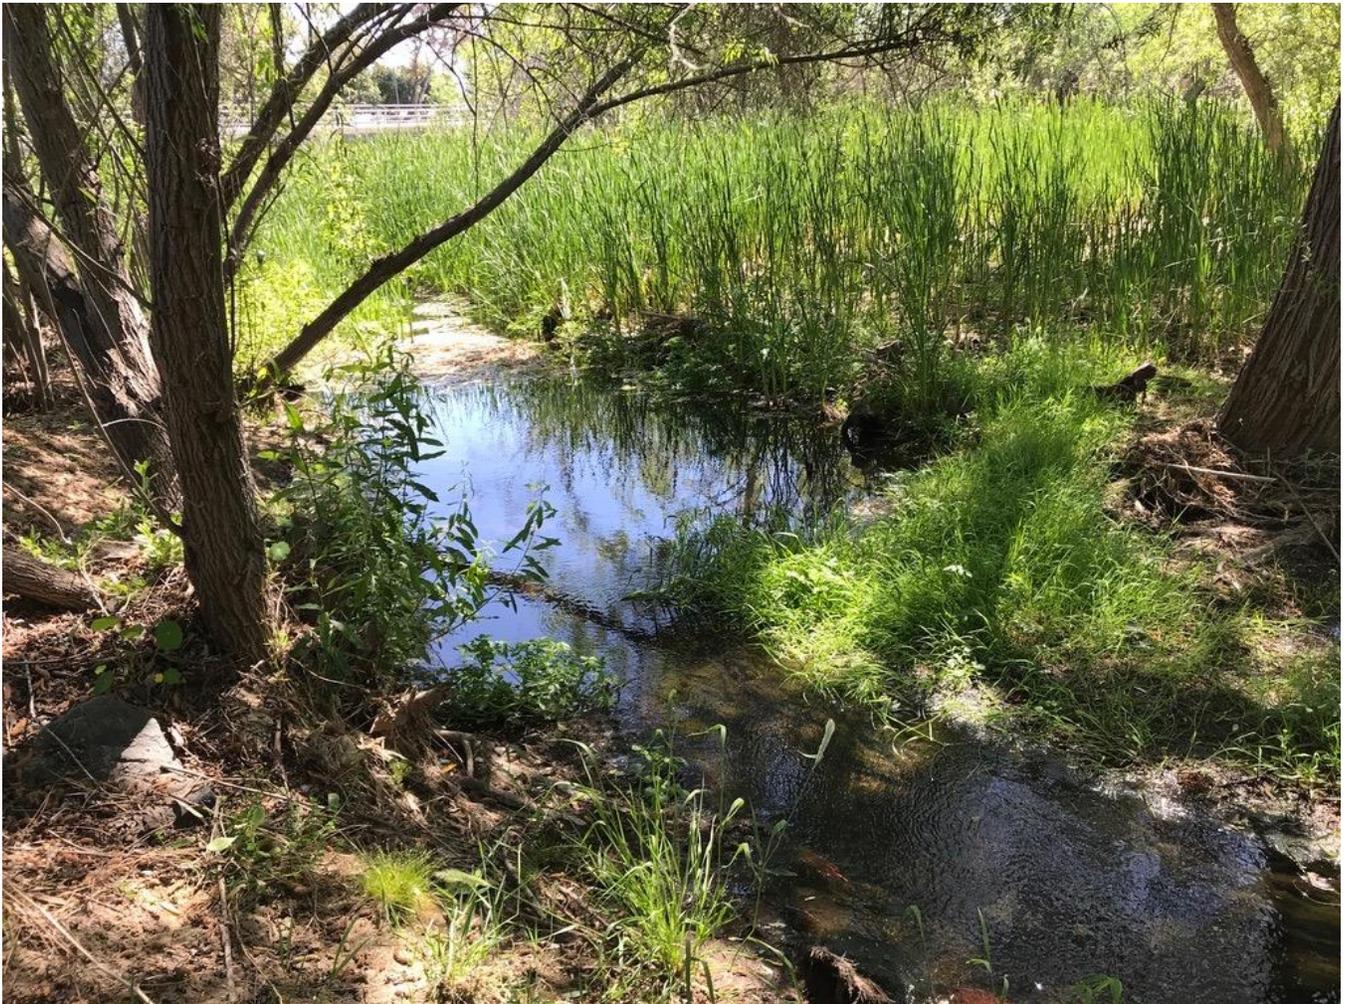
Site AHL010

E.coli levels continue to be above the threshold in sites AHL010 and AHL030 which is cause for concern. This may be due to the fact that AHL010 is a convergence of all of the creeks and we only test two of the creeks. We don't test Little Encinas or other tributaries.
